Some examples of landslide monitoring using Trimble equipment in Europe

Abstract

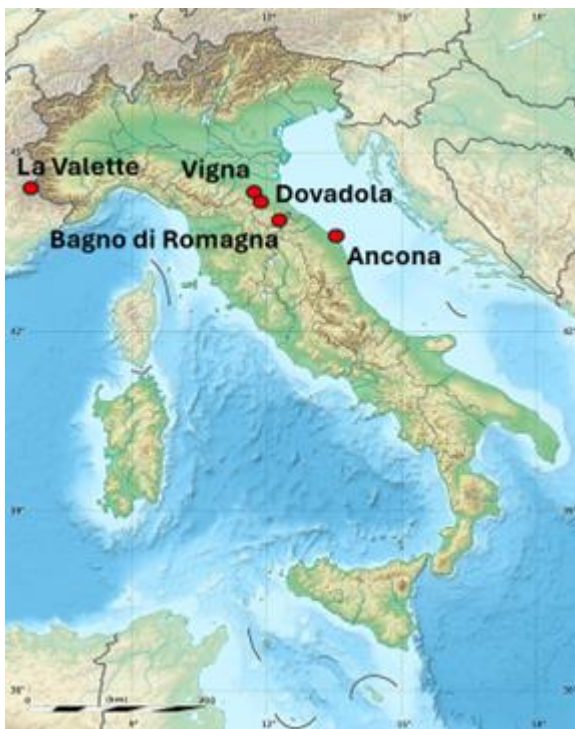
Figure 1. Location of the study landslides in France (La Valette) and Italy (Bagno di Romagna, Dovadola, Vigna and Ancona)

In this paper, we focus on different landslides in Europe using Trimble equipment (Figure 1). In France, an automated station Trimble S9 monitoring the La Valette landslide (Southern Alps) have been installed by the French Landslides Observatory OMIV “Observatoire Multidisciplinaire des Instabilités de Versants” (Malet et al., 2016, www-ano-omiv.cnrs.fr) (Figures 1 and 2).

In Norway, the companies Cautus Geo and Spectra Srl. Cautus Geos have installed several monitoring systems. These systems cannot be developed here for contractual reasons. In Italy, Spektra Srl – a Trimble company have installed monitoring systems in the Apennines mountains and the coastal region of Ancona (Italy) (Figure 1).

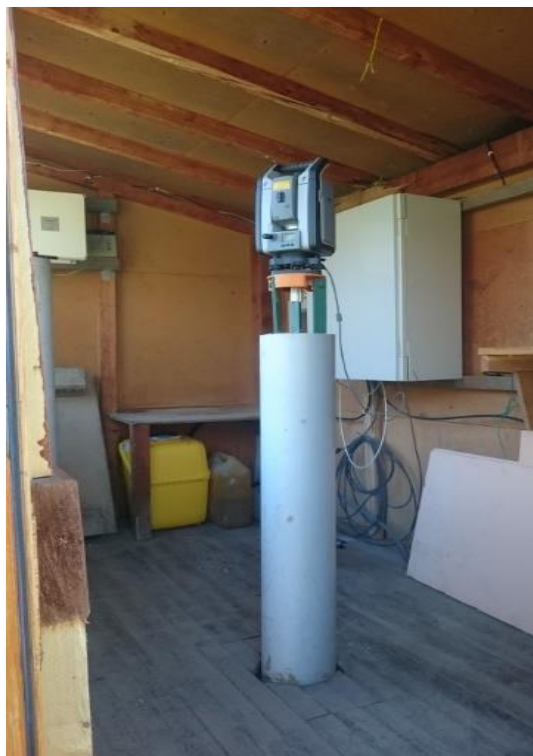
Figure 4. The Trimble S9 automated total station installed at la Valette landslide (Southern Alps, France)

In September 2019, a Trimble S9 total station has been installed and observed reflectors every 1 or 3 hours (Figures 3 and 4; Ferhat et al., 2020, 2024). The targets are distributed along the whole landslide with a higher density in the lower zone which is supposed to be more susceptible to accelerating and because it is closer to the inhabited area downstream (Figure 3).

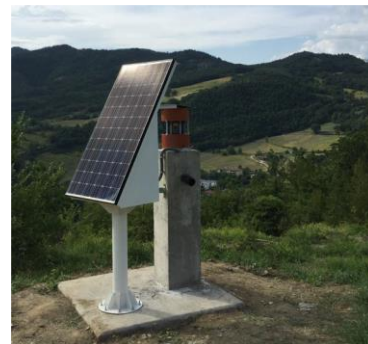
Figure 7. Trimble S9 Long Range total station at Bagno di Romagna landslide (Italy)

In this case, the monitoring system consists of a long-range total station which, at set times, performs measurement cycles on prisms placed at strategic points of the landslide.

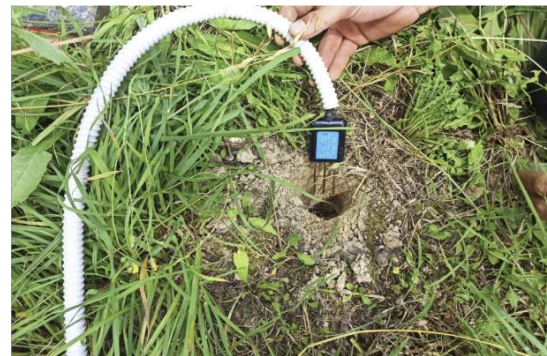
Figure 9. Monitoring system, geotechnical sensors, at Dovadola site (Italy)

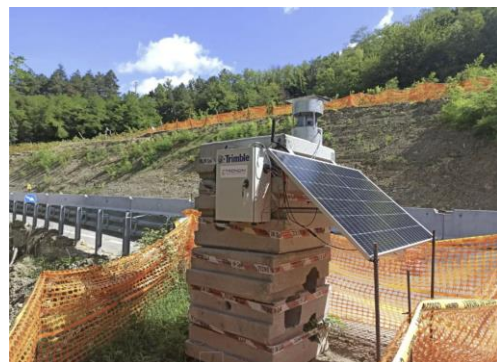
Figure 11. Dovadola site, Trimble S9 total station (Italy)

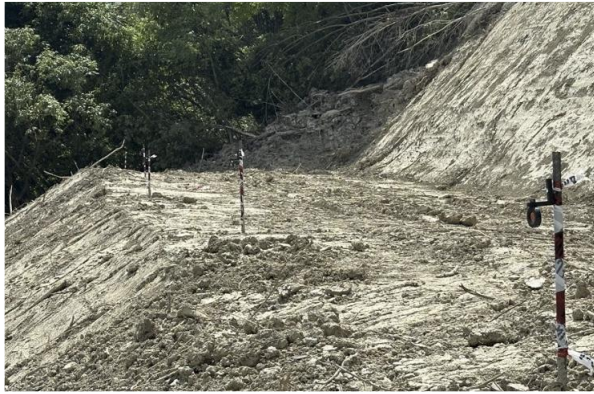
Figure 12. Poles equipped with reflectors at Dovadola site (Italy).

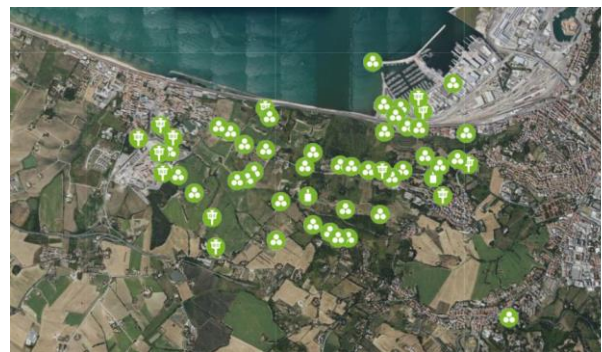
Figure 13. Locations of monitoring points at Ancona site (Italy)

For the monitoring system we are using various technologies (inclinometers, total stations, GPS) indispensable tools for understanding and managing hydrogeological risk, allowing us to adopt effective and timely prevention and mitigation measures (Figure 13).

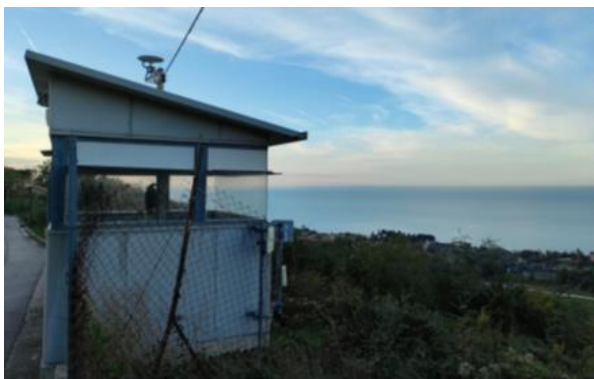
Figure 15. Monitoring system, integrated Trimble S9 total station & Trimble R750 GNSS receiver at Ancona (Italy)
