Development of an expert system for the deformation monitoring of historical sites using Artificial Intelligence (AI)

Krzysztof KARSZNIA^{1,*}, Ewa ŚWIERCZYŃSKA¹, Krzysztof KSIĄŻEK¹,
and Waldemar ODZIEMCZYK¹

¹ *Warsaw University of Technology, Warsaw, Poland, (krzysztof.karsznia@pw.edu.pl, ewa.swierczynska@pw.edu.pl, krzysztof.ksiazek@pw.edu.pl, waldemar.odziemczyk@pw.edu.pl)*

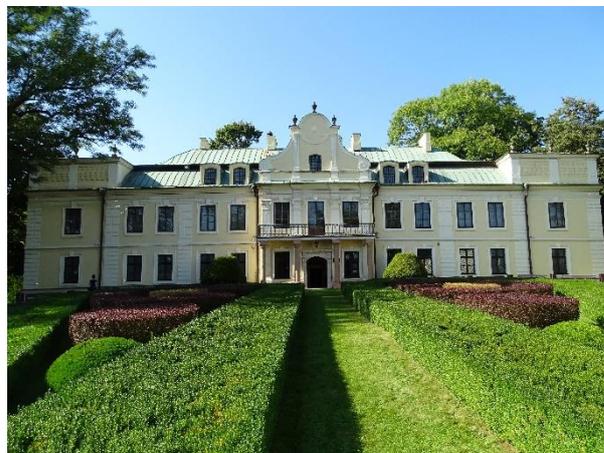
Figure 1 Frontal view of the Mioszowski Palace, Będzin, Poland

For the purposes of this article, the focus is on the main building of the Coal Basin Museum - the Mioszowski Palace, dating from the 18th century (Figure 1).

The two palace bastions - the annexes visible on the left and right - were added more than 150 years after the main body of the building was erected (www.muzeumzaglebia.pl). As the left bastion is located on a slope (fig. 2), the architectural element is subjected to increased displacement, resulting in the appearance of cracks and dilatations inside and outside the building (fig. 3). Condition monitoring
